**South Asia Co-operative Environment
Programme (SACEP)
Plastic free Rivers and Seas for South Asia
(P171269)**

**ENVIRONMENTAL AND SOCIAL
MANAGEMENT PLAN OF SACEP HEAD
QUARTERS BUILDING**

[March 2024]

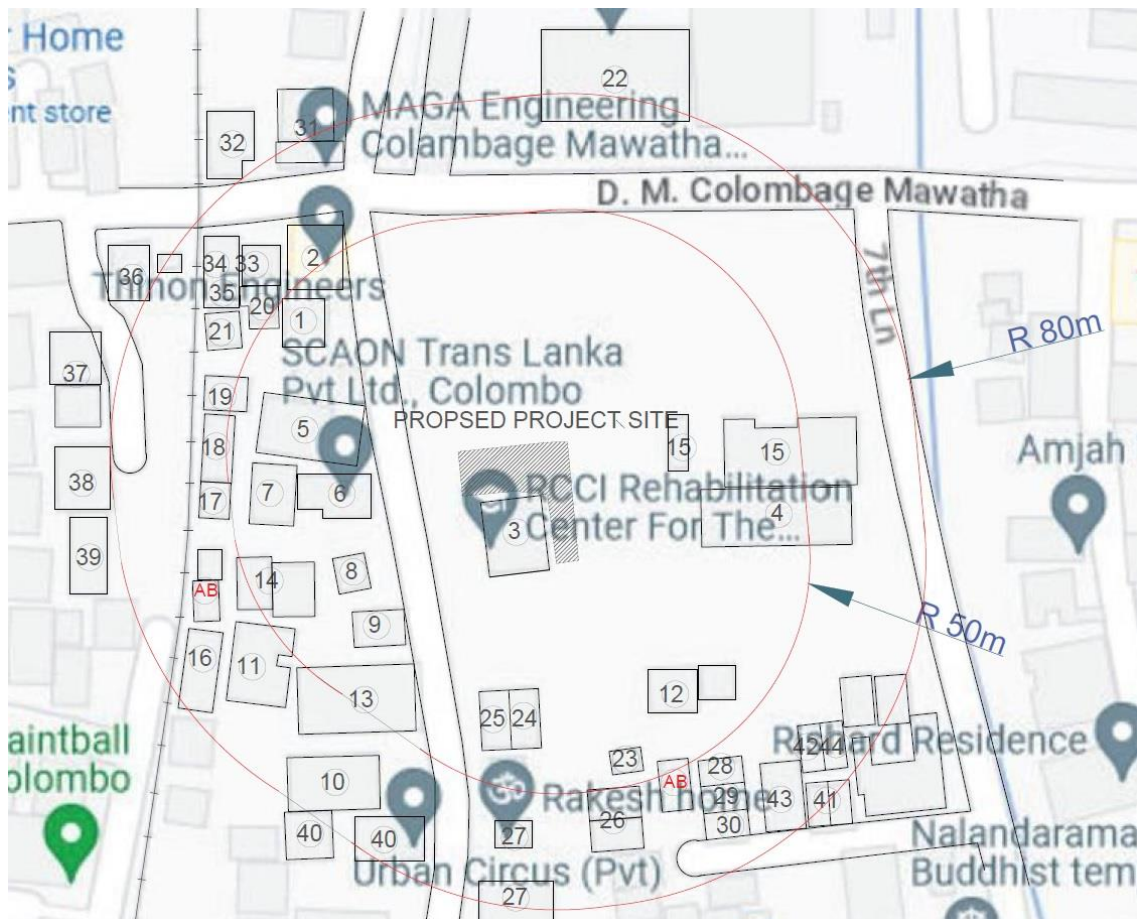
3. Location Map

The Map indicating settlements located within the 50 m boundary and 80 m Boundary of the site
